### **Management of South Port Macquarie Breakwater**

**Report No 2023/02**

**February 2023**

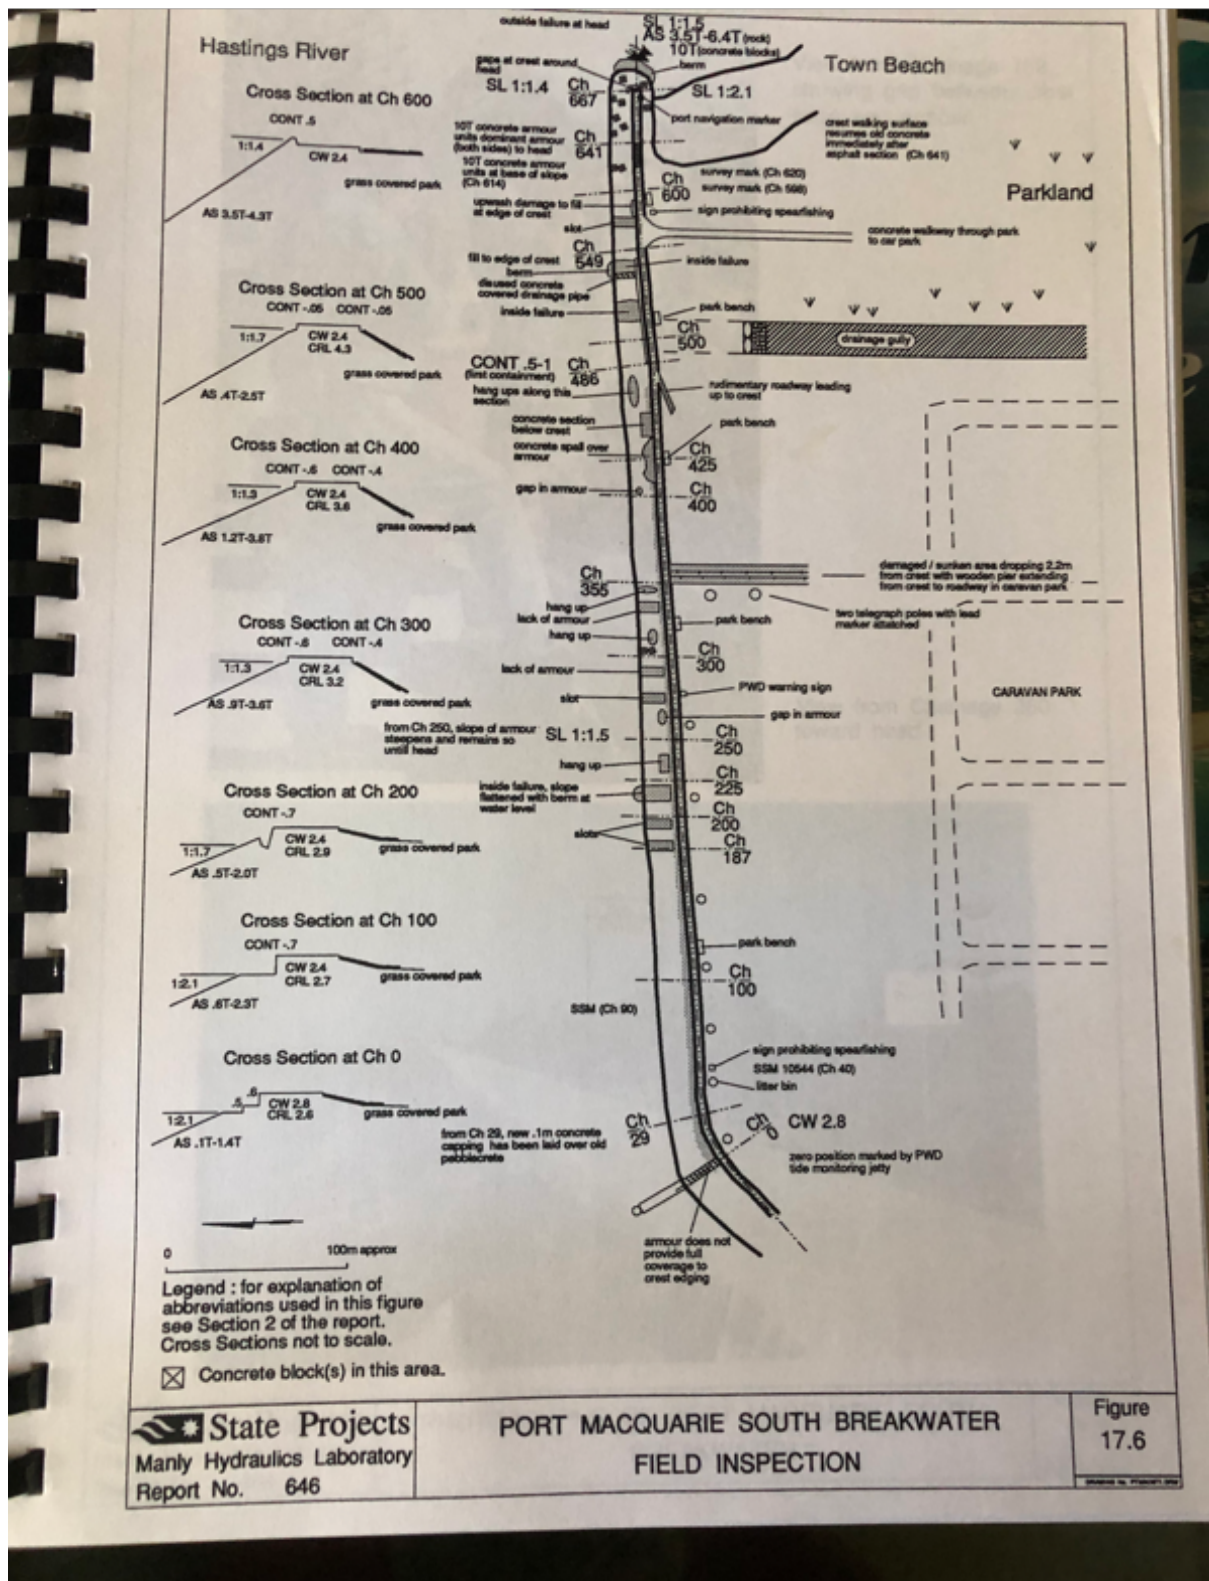
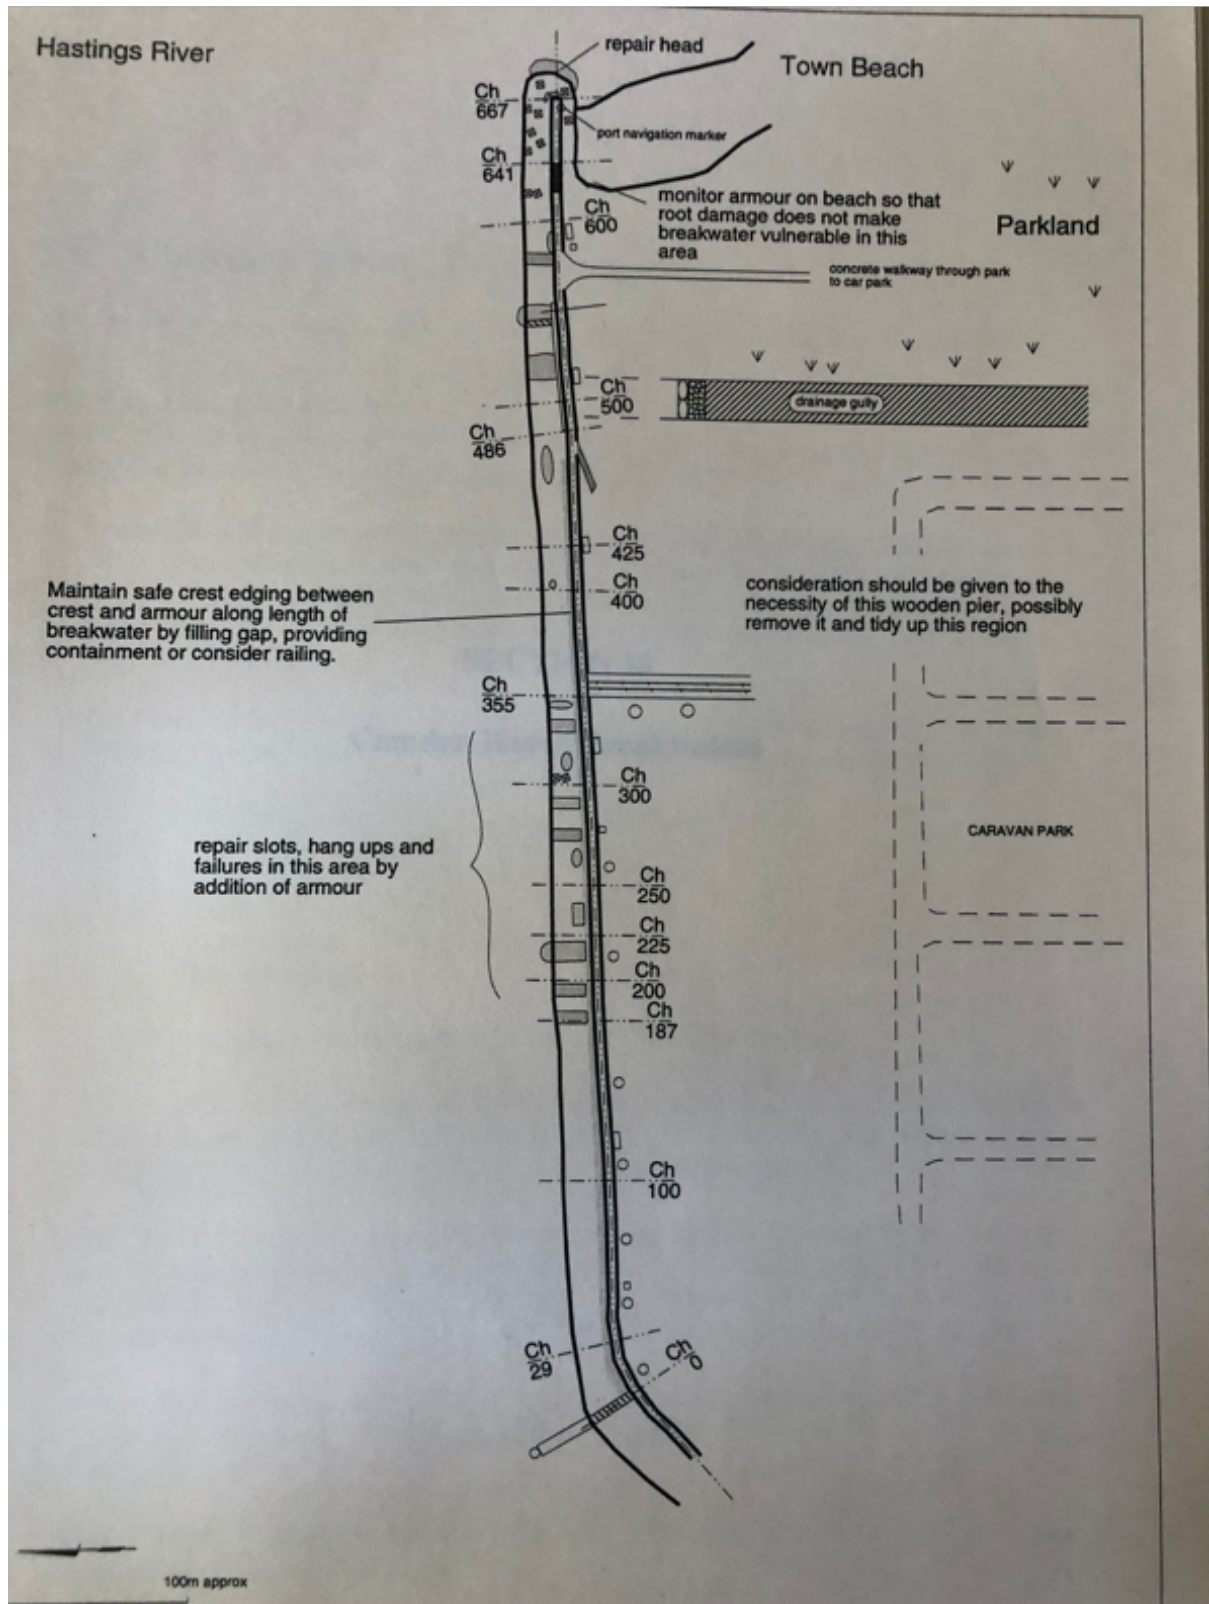
APPENDIX A - MHL 1993 Asset Appraisal and repair recommendations for Southern Wall  
(this summary is supported by 10 pages of detail)

It is important to note that in the MHL appraisal report the difference between the areas identified in the field inspection as against the relatively fewer areas considered to need attention particularly between chainages 187 and 365 and from 500 to the head.
