# Ordinary Council

date of meeting: Thursday 16 March 2023

Assessment of Port Macquarie Southern Breakwall - Angus Gordon

## Management of South Port Macquarie Breakwater

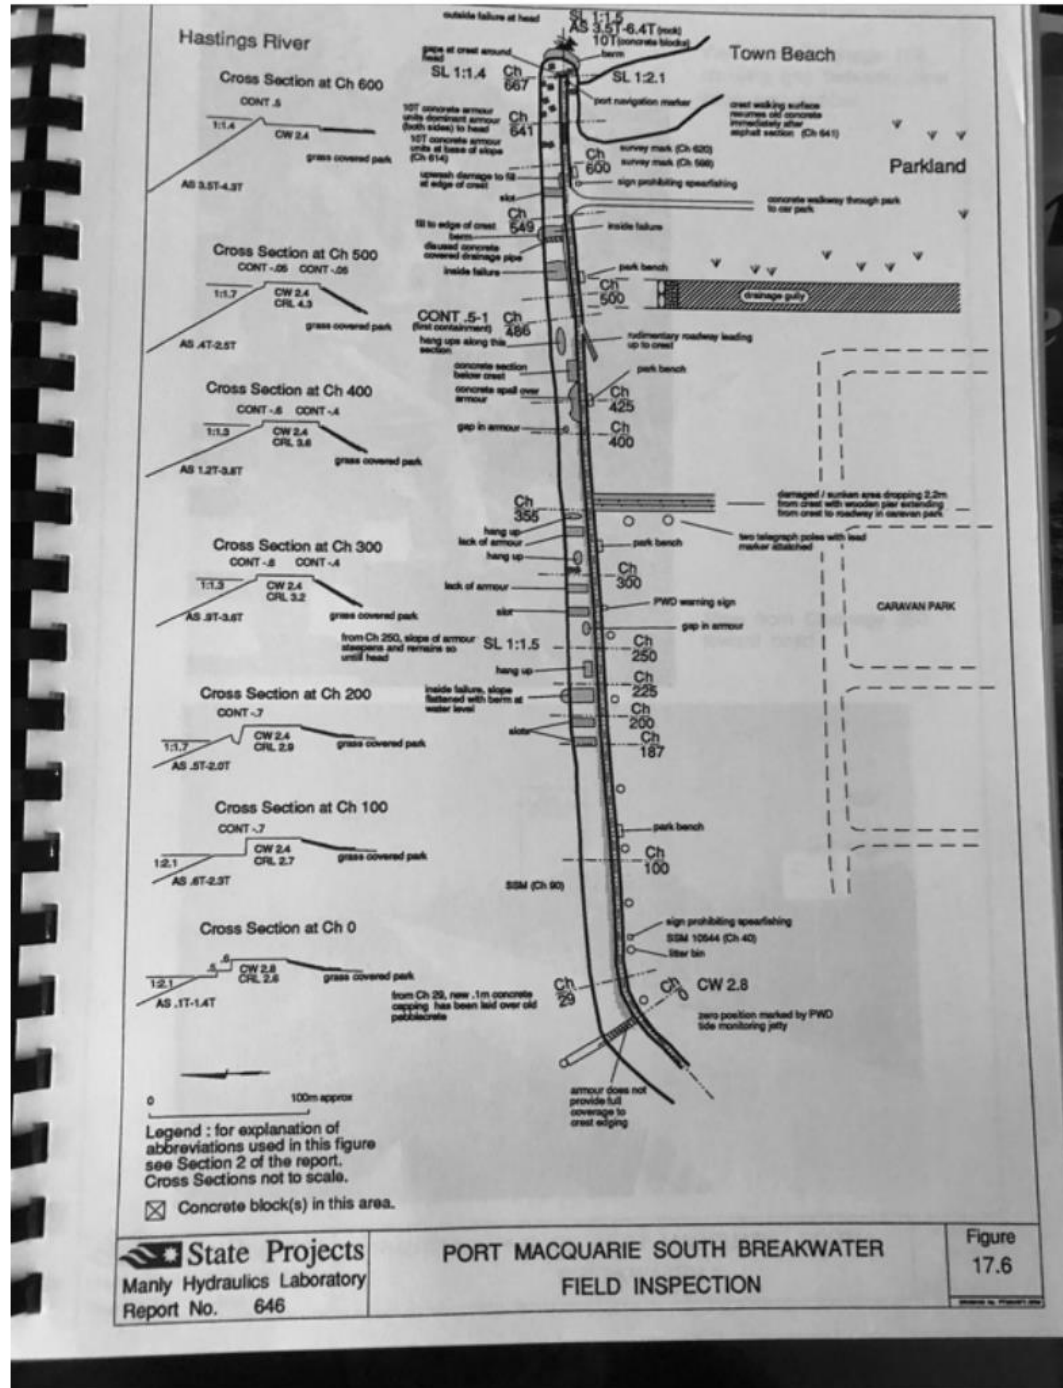
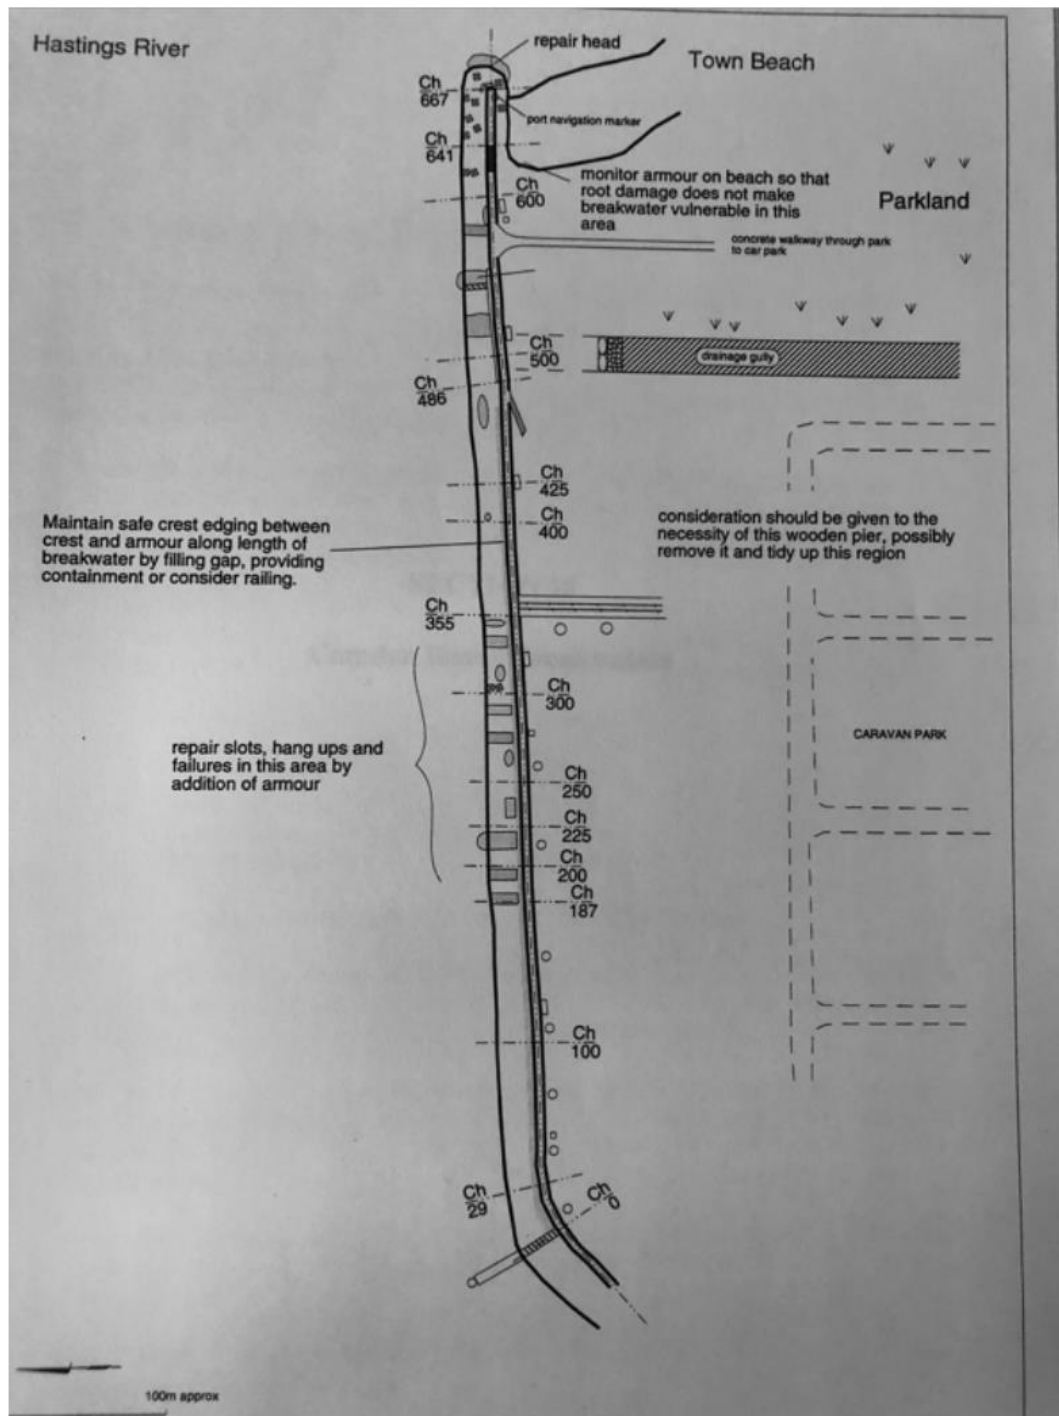
APPENDIX A - MHL 1993 Asset Appraisal and repair recommendations for Southern Wall  
(this summary is supported by 10 pages of detail)

It is important to note that in the MHL appraisal report the difference between the areas identified in the field inspection as against the relatively fewer areas considered to need attention particularly between chainages 187 and 365 and from 500 to the head.
